Roper Solar Greenhouse Energy Audit

Donation of [Energy Check](#), Blacksburg VA

Audit was performed by Joe Mugavero.

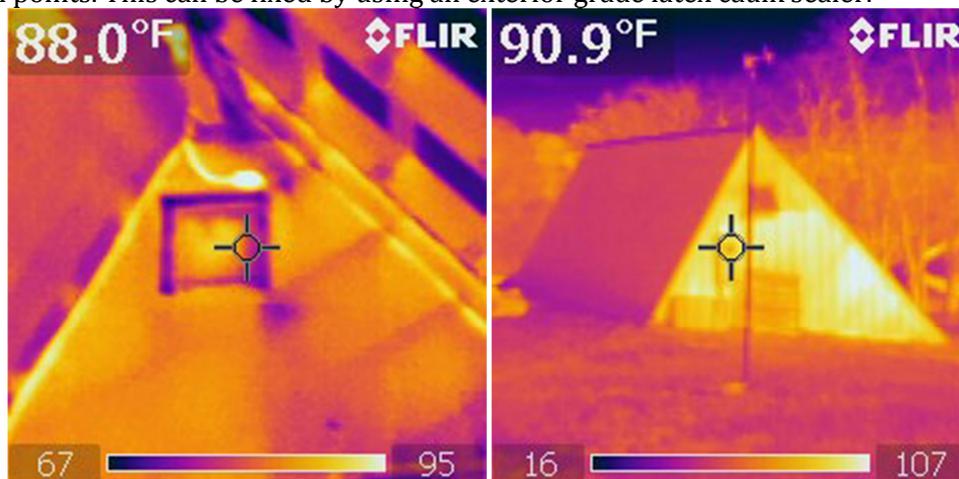
1. The peak of the vaulted roof design has small amounts of air leakage at the beam connection points. This can be fixed by using an exterior grade latex caulk sealer.

We need to bring a long ladder in and caulk the peak. Note the heat leakage at both the top and bottom of the roof.

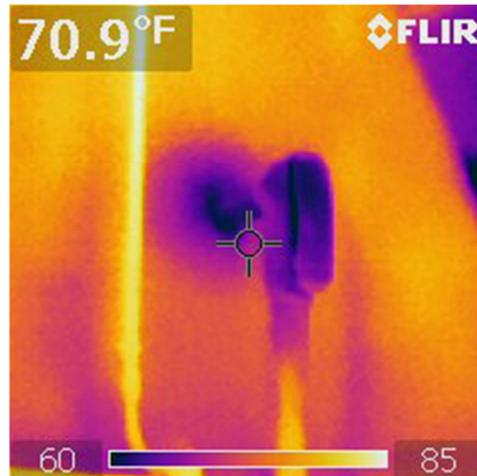
2. Wall penetrations on the West wall pose the largest amount of air leakage. The electrical conduit pipes from outside should be sealed.

This was fixed by spraying foam into the electrical connection.

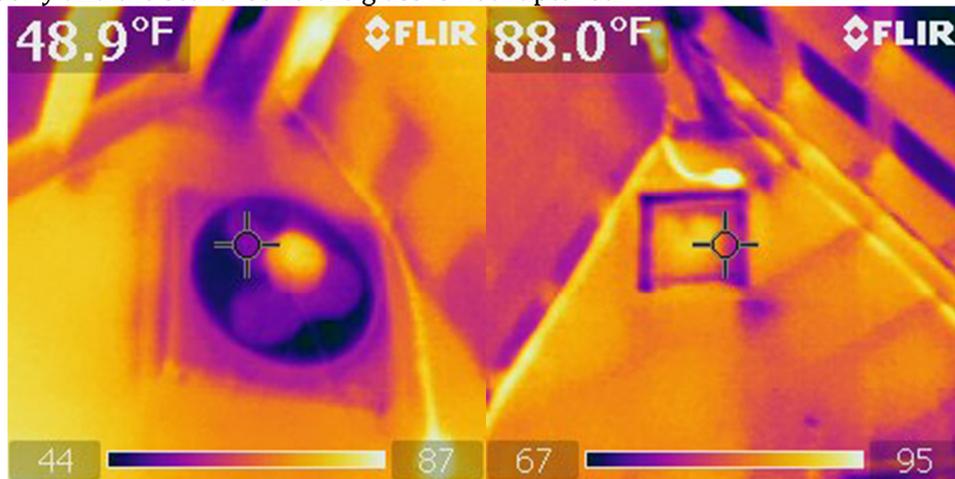
3. The West window performs poorly based on thermal imagery. Be sure this window closes properly and the seal around the glass is not ruptured.

The first picture is the west window, the second picture is the east window. We later discovered that the west window was not fully closing because the window latch was not fully latched open.

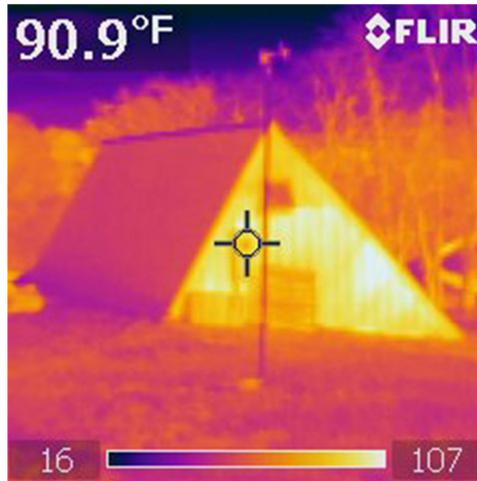
4. There is some apparent air leakage inside the north wall and roof assembly. For peak energy performance, this should be minimized at the sill plate from outside.

Note the heat leakage at both the top and bottom of the roof.

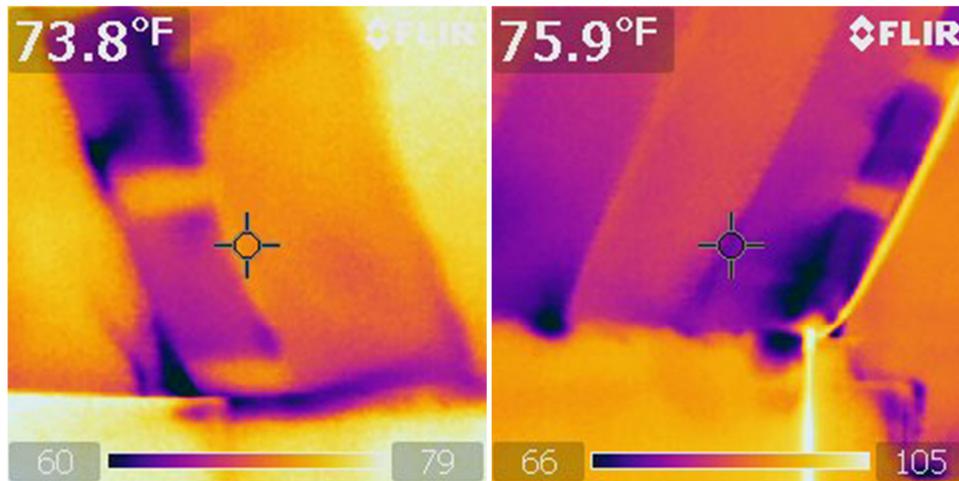
The heat leakage at the west and east ends of the roof is due to construction since boards took up space that was then not available for insulation.
