Roper Solar Greenhouse Energy Audit

Donation of [Energy Check](#), Blacksburg VA

Audit was performed by Joe Mugavero.

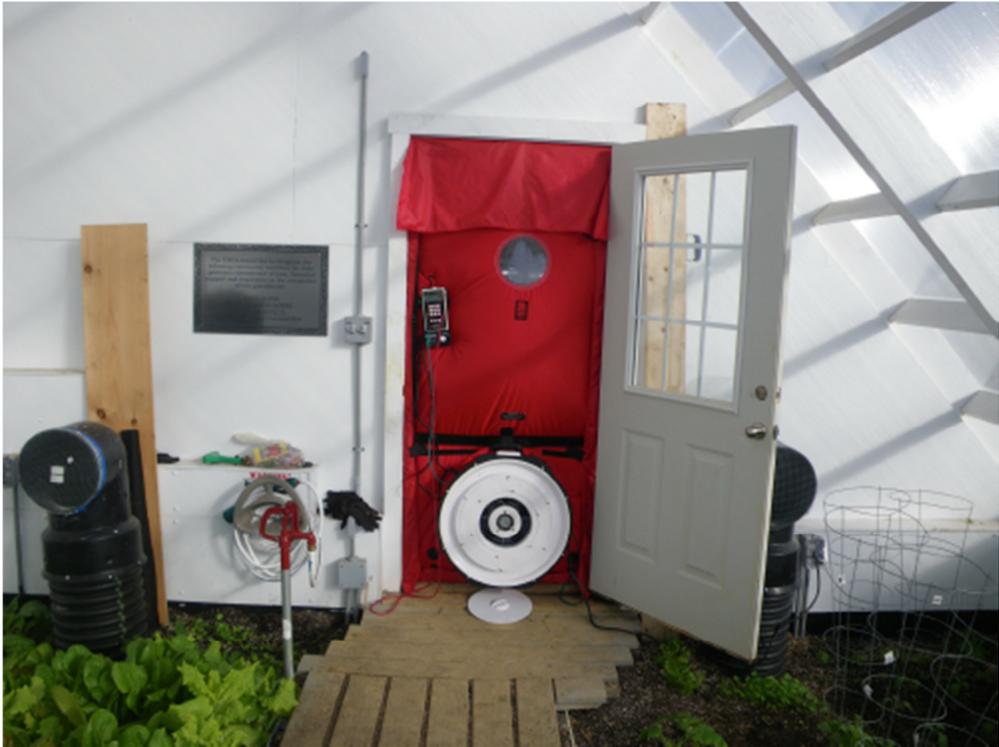
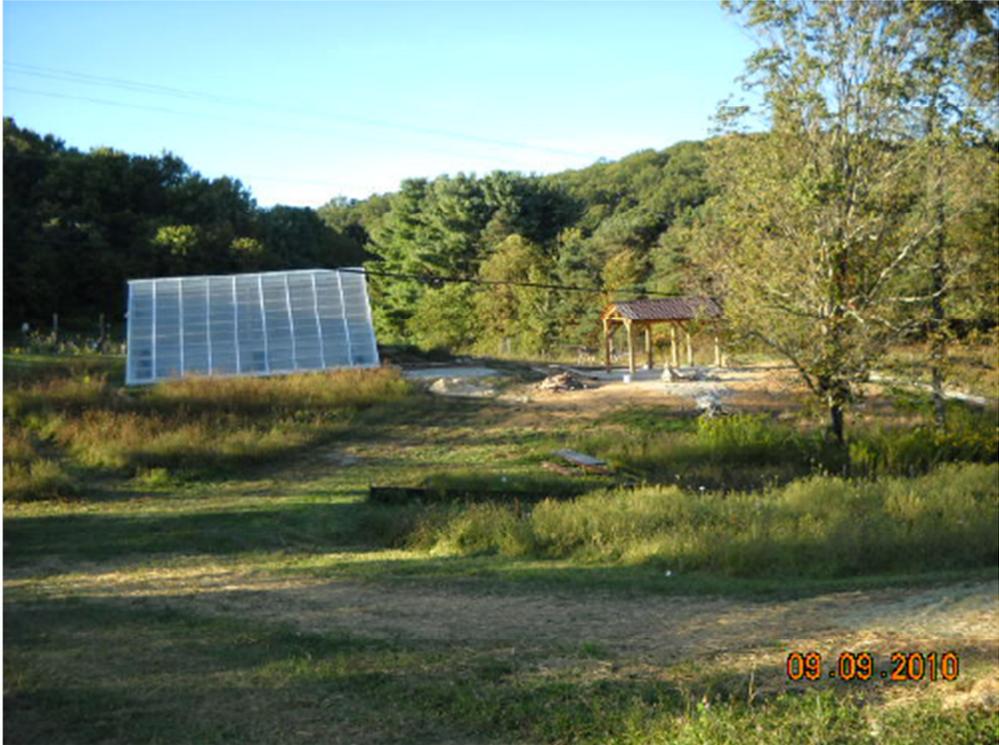
Blower-Door test

The blower door test revealed .06 ACH, with a total air infiltration opening of 16 square inches (about the size of a 4" hole being open at all times). This is considered very energy efficient according to ASHRAE and BPI, Inc. standards.
